WHEN CUSTOMER SPECIFICATIONS FOR A PRODUCT LIE OUTSIDE A PRODUCT'S MATERIAL PROPERTIES AND PROCESS CAPABILITY - A CASE STUDY

To avoid losing a \$12M client, a vendor addressed complaints that their disposable baby bottle liners failed hot water pressure tests and had widths outside specifications. The prescribed resin's softening point was (980C (208.40F)). At the vendor's testing site (580 meters above sea level) water boils at 97.20C (2070F). At the client laboratory (11 meters above sea level) water boils at 99.40C (2110F). Thus liners that met vendor specifications failed at the client's laboratory. An alternative resin (softening point: 1070C (2230F)) was found to meet client specification. A process capability study revealed that the machines were incapable of producing liners to client specifications. Further investigation revealed that the complaints related to problems customers had extracting liners from the package. An out-of-round packaging core provided by another vendor was the cause of uneven extraction. Changing resins and ensuring cores were in-round resulted in meeting the client's quality concerns.

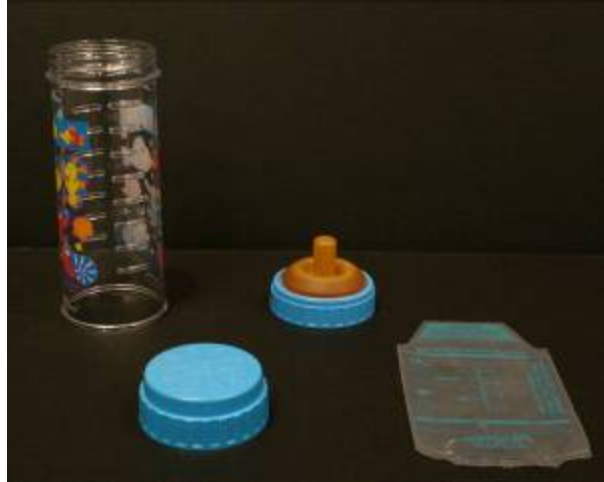
Figure 3: Unassembled Baby Bottle Components
{Permission granted by Liz McCarthy (photographer)}

At a minimum of every four hours, inspectors pulled 12 baby bottle liners randomly from each machine for the HWPT. The test involved fitting the liners on baby bottle cylinders identical to those used by consumers. Figure 3 illustrates the components assembled to prepare a bottle for use. The test pressurized the liners internally with air and simultaneously immersed them in boiling water. The internal air pressure reached 17.65 grams per cm² to a depth of 19.05 cm for the 236.59 ml liners and 8.89 cm for the 118.29 ml liners. The samples are maintained at this pressure in the water bath for 60 seconds. A failure occurs when the liner's wall or seal leaks air under pressure. Figure 4 illustrates a 236.59 ml liner seal failure.

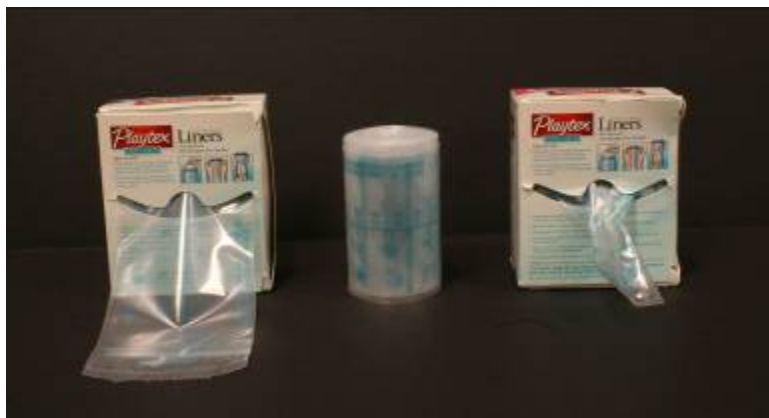
Figure 5. Liner Dispenser, Acceptable (left), Spooled Liners (center), and Unacceptable (right)
{Permission granted by Liz McCarthy (photographer)}

The client assembled and packaged the product after receiving the liners, then sent them to the marketplace. The client expected the end customer to be able to draw each liner from the package smoothly and evenly. The liner should not crimp at the package's precut slot. A conforming dispensed product is illustrated in figure 5-left. In the figure's center is a spool of 80 liners. A liner that crimped had the potential to result in dispensing failure (figure 5-right). The dispensing failure created the customer discontent. There were repeated instances of dispensing failure which the client ascribed to

unacceptable variation in liner width. Tests performed at the vendor's confirmed that the liners were not consistently in conformance with the dimensions specified by the client.

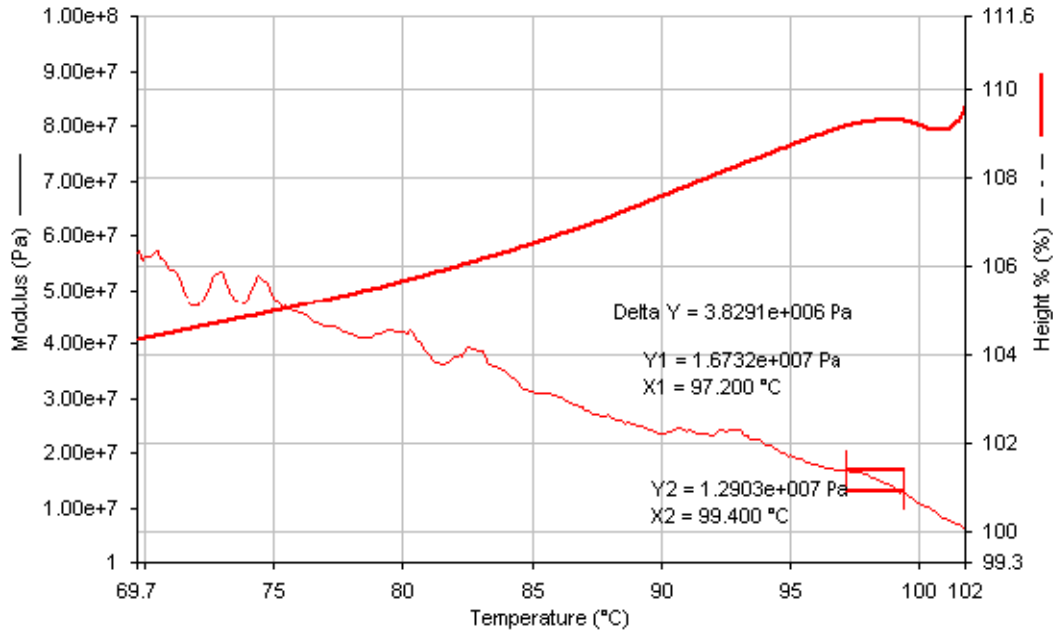
Figure 6: DMA Testing of Storage Modulus (Stiffness) at Two Temperatures

In addition to Vicat Softening Point testing, the vendor submitted samples to their Neenah Technical Center for further evaluation of the LDPE material. The Neenah facility conducted a Dynamic Mechanical Analysis (DMA) test. This particular DMA test measured the mechanical properties of the material (stiffness) and elongation as a function of temperature. The bolder line in figure 6 represents the percent difference in height as a function of temperature and the thinner line represents stiffness as a function of temperature. A tensile load of 2500 grams per square centimeter was applied to a sample at a continuum of temperatures, including the vendor and client test temperatures. The DMA results indicate that the modulus drops 23% in going from vendor test temperatures to client test temperatures (as indicated by the data points in the lower right-hand corner of the graph). In addition to the DMA testing, a Differential Scanning Calorimeter (DSC) Heat of Fusion test was performed in order to determine the percent of crystalline still intact at a range of temperatures. The DSC test measures temperatures and heat flows as thermal energy is applied to the material. The bolder line represents percent area (or percent of crystalline no longer intact) as a function of temperature.

The client had specified both the particular low density polyethylene (LDPE) resin and the raw material's vendor. This particular LDPE has a Vicat Softening Point of 98°C (208.4°F). The test temperature (boiling water) at the client's testing facility is 1.4°C (2.6°F) above the softening point. In attempt to determine assignable cause for HWPT failures, other available LDPE resins from the current raw material vendor with higher melting points (112°C) were tested. The vendor then tested medium density polyethylene (MDPE) resins with a Vicat Softening Point of 107°C (223°F) from a competing vendor. Further testing of available LDPE resins with higher melting points (112°C) acquired from the specified raw material vendor revealed that such resins could meet specifications at the vendor's facility but would still have an unacceptable failure rate at the client's testing facility. It became evident that the LDPE resins supplied by the current vendor would not meet client specifications (Lyda, 2002). The medium density polyethylene (MDPE) from a competing vendor met the customer's general raw material specifications and, with a Vicat Softening Point of 107°C (223°F), the HWPT results met the liner's seal and wall strength specifications as well.

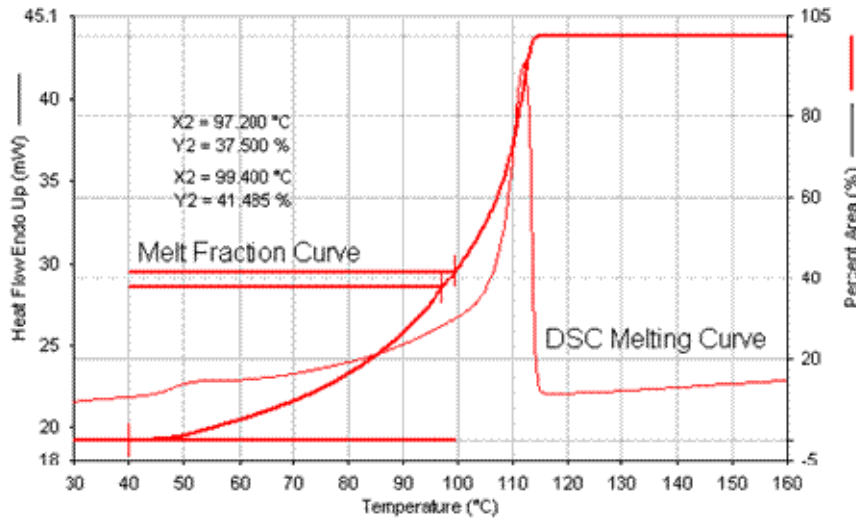
Figure 7: DSC Heat of Fusion Testing Results (calculations of percent of crystalline phase that is melted)

The thinner line depicts heat flow as a function of temperature. The DSC results in figure 7 show that at the 99.4°C (211°F) boiling point, only 2/3 of the crystal structure of the LDPE remains available to resist the test pressure. Analysts wondered how any of the liners passed the HWPT in only 2/3 of the crystal structure remained intact at the Dover test temperature. The posited explanation is that fluctuations in the film thickness affected the quality of the seal. The film for the baby bottle liners was on average 55.8 microns thick, but the thickness naturally varied. When the film was thinner, the seal grew weaker. The thicker film had a much higher probability of passing the HWPT at the 99.4°C (211°F) test temperature (Lyda, 2002).

The client’s marketing team was presented with bags made of both the LDPE resin and the MDPE resin. Unaware of the differences in the bags, the marketing team preferred the medium density resin to the low-density resin. The salesmen believed the MDPE film to have superior optical properties in comparison to the LDPE liners (note the haze in the spooled liners in figure 5). The MDPE liners had better clarity, which is a term that describes the measure of transmitted light through the film. This is qualitatively determined by reading distant text through the film. The MDPE liners also had lower haze, a term that describes the cloudiness of the film, or the amount of scattered light. This, too, is qualitatively judged by looking at an object through the film. Based upon the limit to the inherent capabilities of the LDPE resin, the client made the decision that to maintain HWPT criteria and to produce a superior product it was necessary to cancel the current resin contract and establish a contract for the MDPE resin with a new raw material vendor. Since this decision there have been no more HWPT failures.

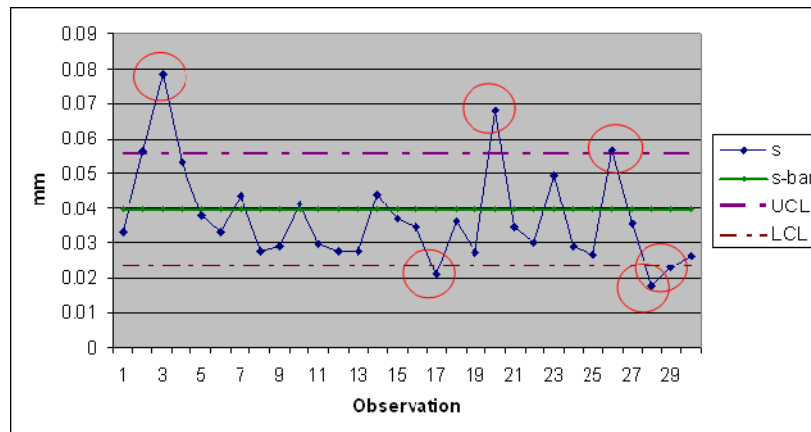
Figure 8: S-chart Results

The s-chart, figure 8, was compiled by using the standard deviation of each group. This chart was used to determine if the standard deviation, variation, of the process is an assignable cause for the x-bar chart to not be in control. Calculated control limits using an s-bar 0.0895547 cm were 0.125377 and 0.053733 cms for the upper control limit (UCL) and lower control limit (LCL) respectively (Grant and Leavenworth, 1996). As figure 8 illustrates, the standard deviation of the process has six out of control points. Thus the processes variation is out of control. With six points outside of the control limits with three above the upper control limit and three below the lower control limit, process variation is too extreme to warrant constructing an x-bar chart.

Since it was determined by the s-chart that the variation was out of control, it was not appropriate to prepare an X-bar chart. Since s-bar is used in the calculations of the X-bar charts upper and lower control limits, any analysis of the X-bar chart would be confounded with variation error (Grant and Leavenworth, 1996). Once the variation was under control, an X-bar chart would be prepared.

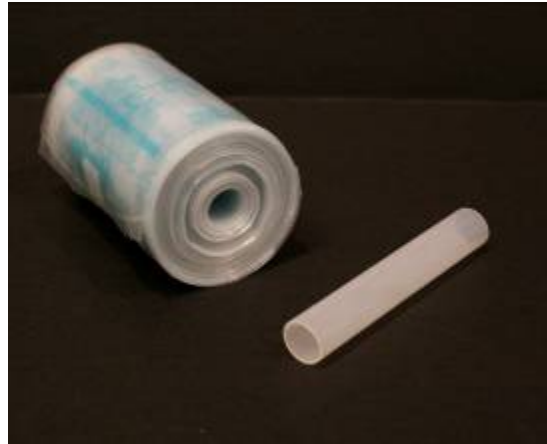
Figure 9: Liner Roll Core {permission granted by Liz McCarthy (photographer)}

The number one quality error is “*Defining quality in terms of your goals instead of your customers’ needs and wants. Standards and policies were set by management without input from customer*” (Russell, 1990). Some of the liners did not fit into the dispenser evenly but analysis and inspection showed that the problem was not caused by the variation from the extremely tight specifications for width but was caused by variations in core alignment. Figure 9 illustrates one of the cores (8.84 cm long by 1.65 cm in diameter with a wall thickness of 0.15 cm) that are used to roll the liners during the production process.

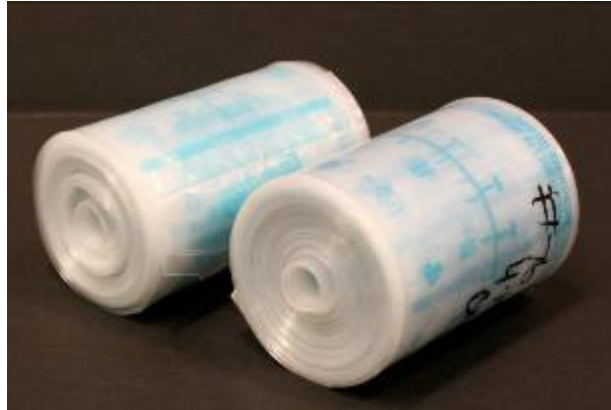
Figure 10: Liners Unevenly Rolled on a Non-Conforming Core (left); Liners Evenly Rolled on a Conforming Core (right)
{Permission granted by Liz McCarthy (photographer)}

Figure 10 illustrates a comparison. The roll on the right meets client specifications and is evenly rolled. The roll on the left, is an unacceptable processed roll where the edges of the roll are uneven, compromising the dispensing of the product. Figure 11 shows a packaged product where the core was evenly rolled on center on the right side of the picture. The example on the left shows a packaged product that where the liners are unevenly rolled. Note that the core is visible. Since liners that are unevenly rolled crumple when pulled from their dispenser (box), the customer is inconvenienced. The customer is not concerned about the dimensions of the liner if the functions are not compromised. The liner width, as long as it fits in the bottle and no leakage occurs, is not important except for the ease of obtaining a liner from its dispenser. The client and the vendor jointly determined that liner width was not a critical quality measure. Russell (1990) emphasizes that specifications and tolerances that are not important to customer expectations should not be a matter of measurement or concern. To ensure that the cores would hold true center while rolling liners in the production process, the client and vendor worked to develop specifications and tolerances for the cores that created conditions where the cores were in round and did not exceed a specified length.

As long as no leakage occurred, liner width was not a customer issue. Once the packaging cores were in conformance and the process was meeting the targeted nominal mean (p_0) on the core, the liners were conforming to customer expectations. Since these changes have been made there have been no major customer complaints on dispensing liners from their packages.
